## **Stormwater Pollution Prevention Plan**

Riverview Innovation & Technology Campus  
3875 River Road  
Tonawanda, New York 14150  
BCP Site No. C915353

05/29/2020

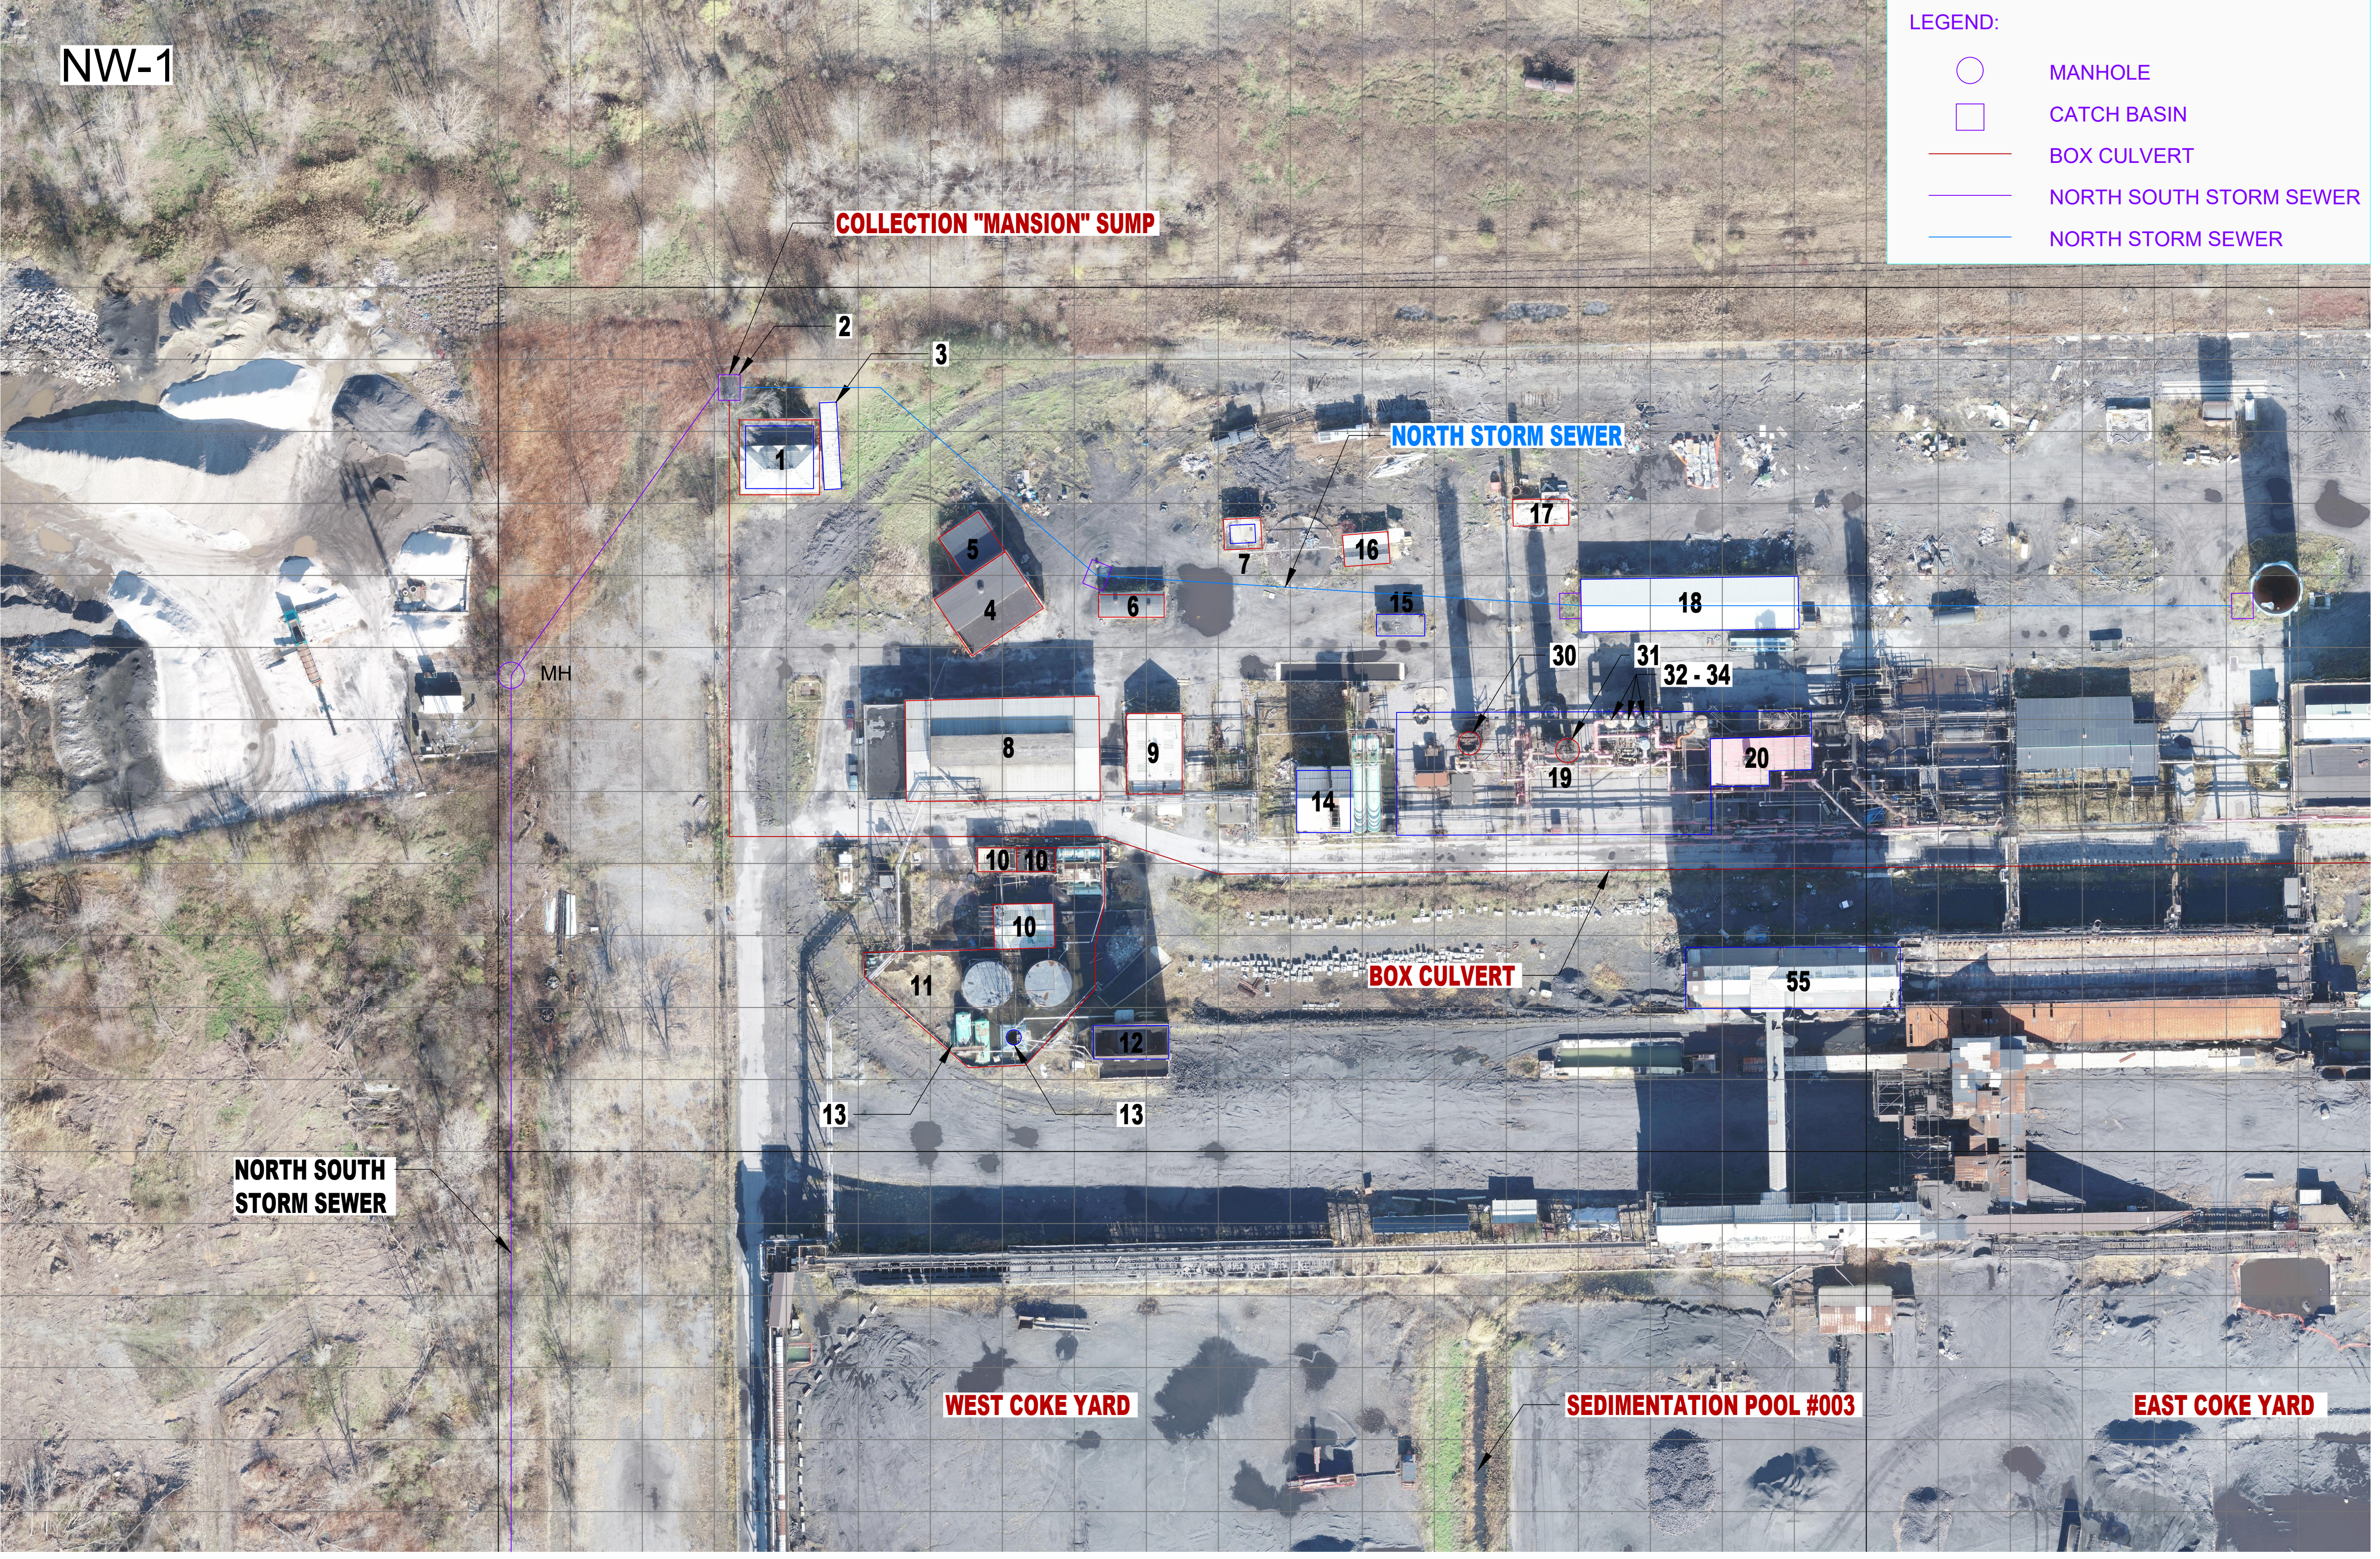
**NORTH WEST SECTION OF PROPERTY  
SURFACE WATER MANAGEMENT**

-   MANHOLE
-   CATCH BASIN
-   BOX CULVERT
-   NORTH SOUTH STORM SEWER
-   NORTH STORM SEWER

- Maintaining storm sewers. The storm sewers throughout the former production area (AOI 2, Figures 2, 3 and 4) require periodic cleaning. The cleaning is conducted after the flow is restricted at the site.

In addition, absorbent materials and standby clean drums and buckets are available on the site. The spill kits are located at the maintenance office - Figure 3, Building 8, Grid E7 and by the guard shack – Figure 7, Building 70, Grid E31.

3. The Process Wastewater Tank Areas (AOC 3 Grids F9 to I11, Figure 3 and AOC 6 Figure 7 Grids E32 to N 34) are inspected weekly to identify all accumulations of liquids in the secondary containments.

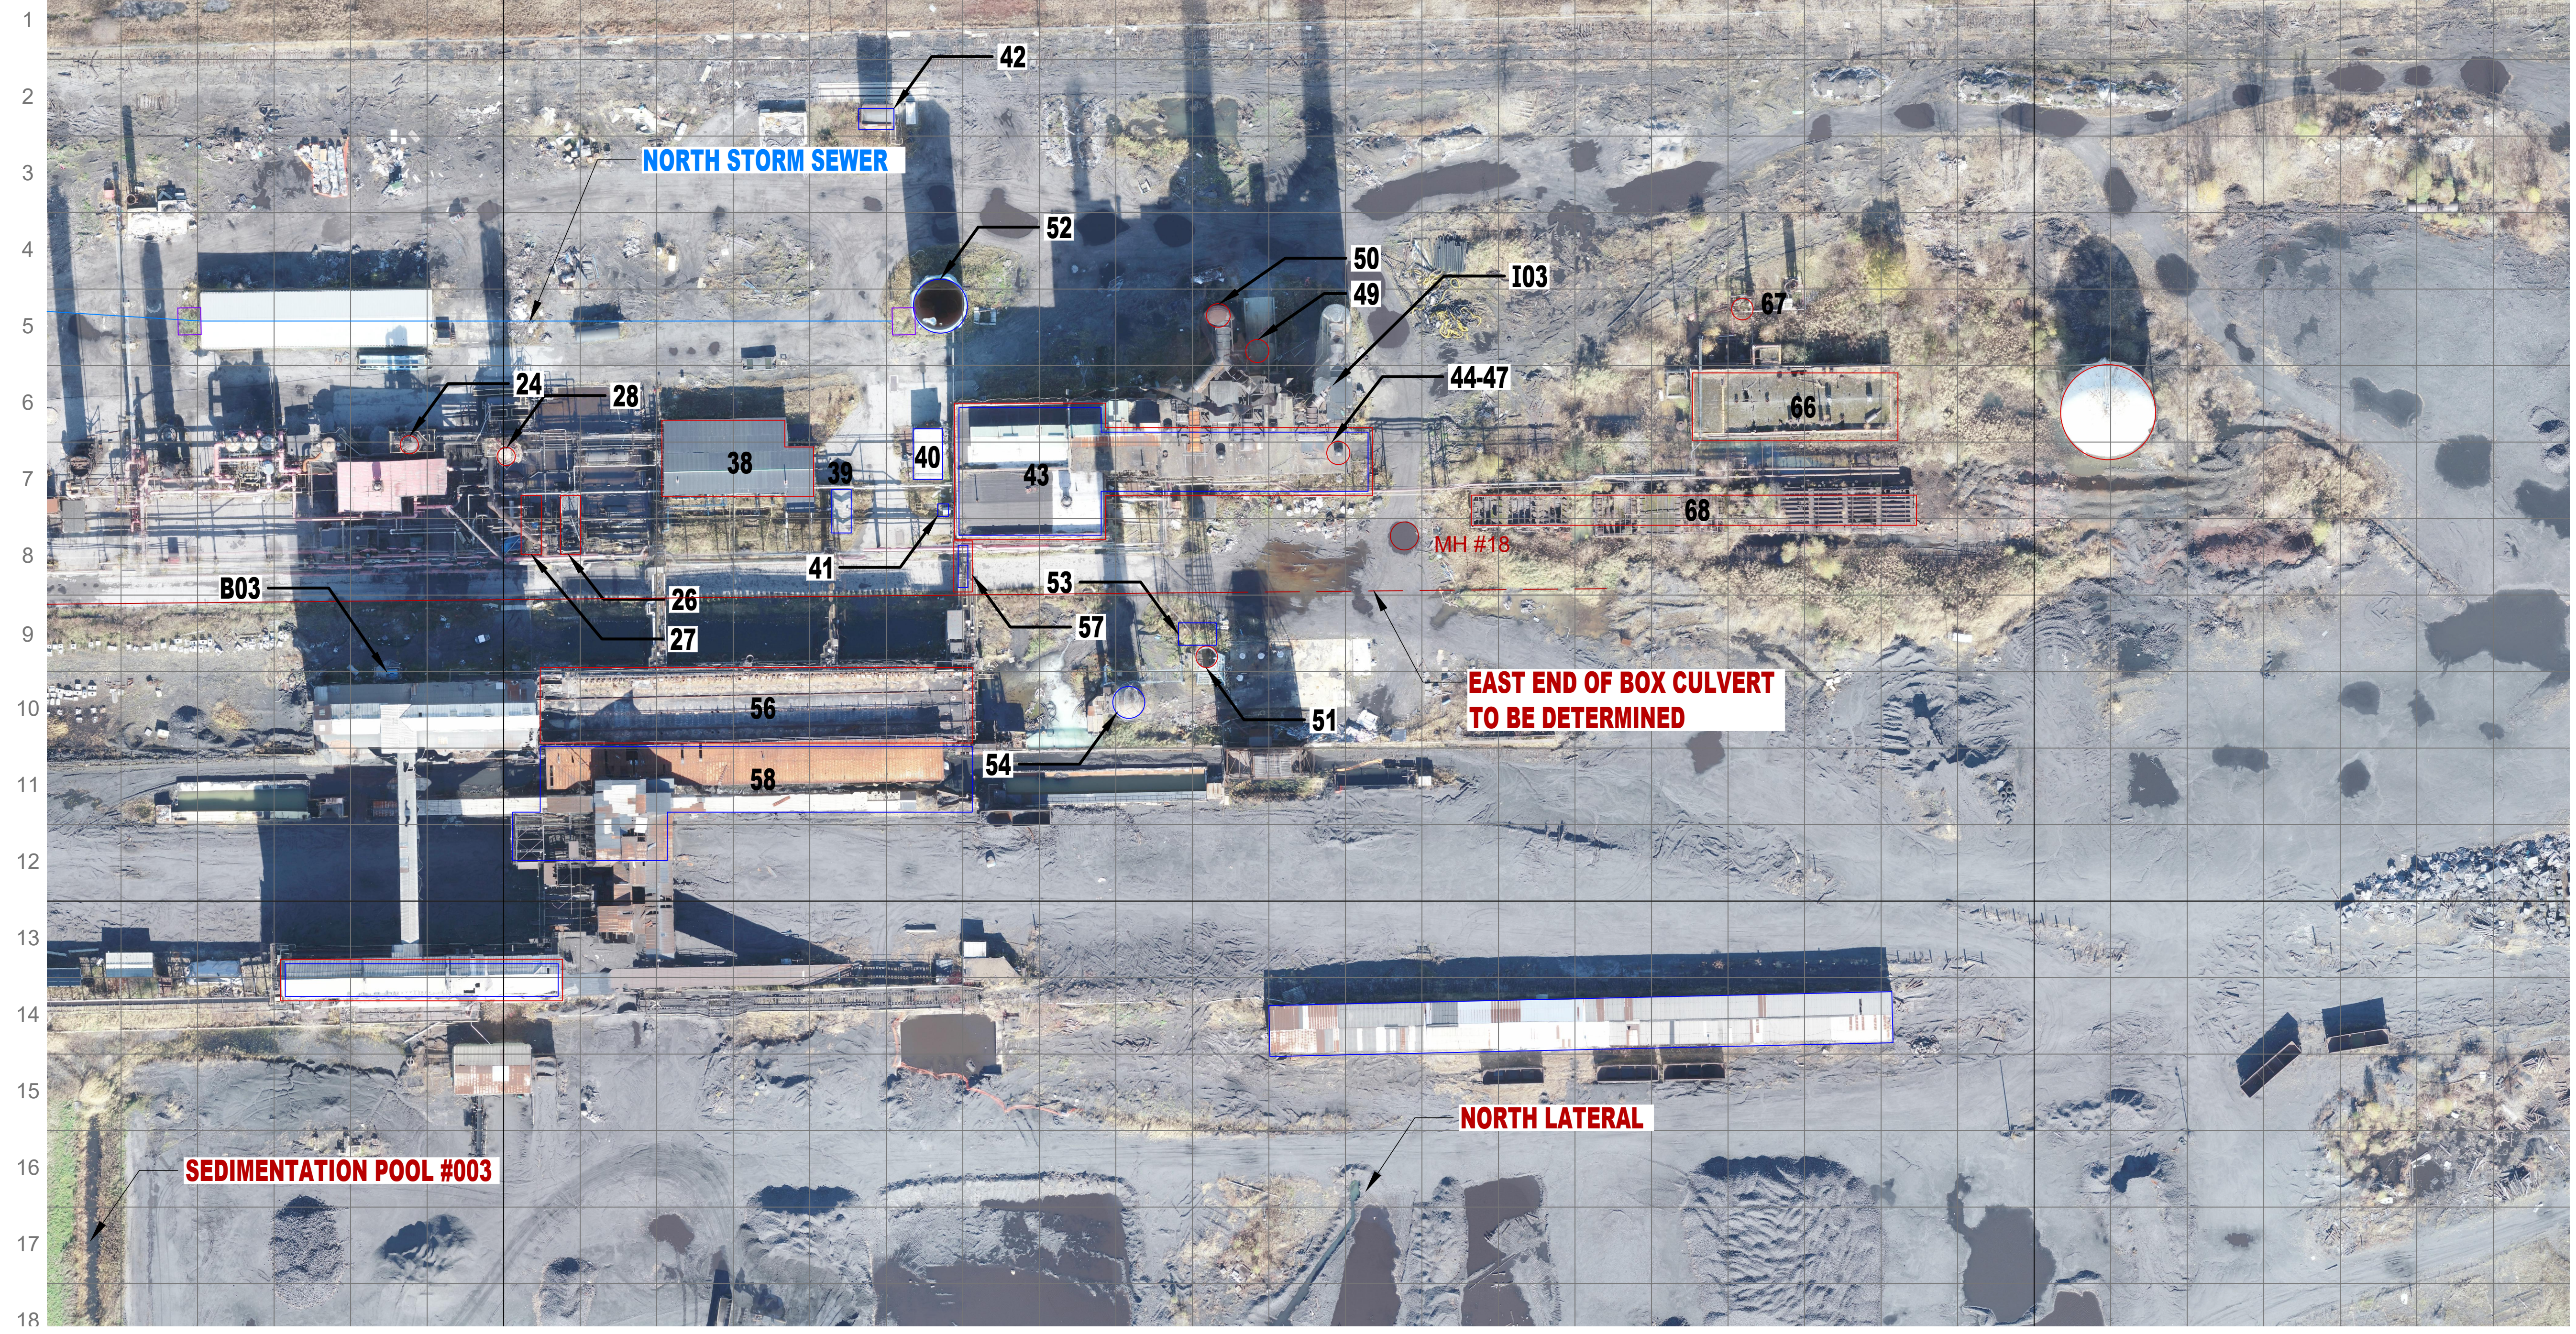
**FIGURE 4**  
 DRAWING NUMBER  
**107A**

NOTE: SEWER LOCATIONS ARE APPROXIMATE.

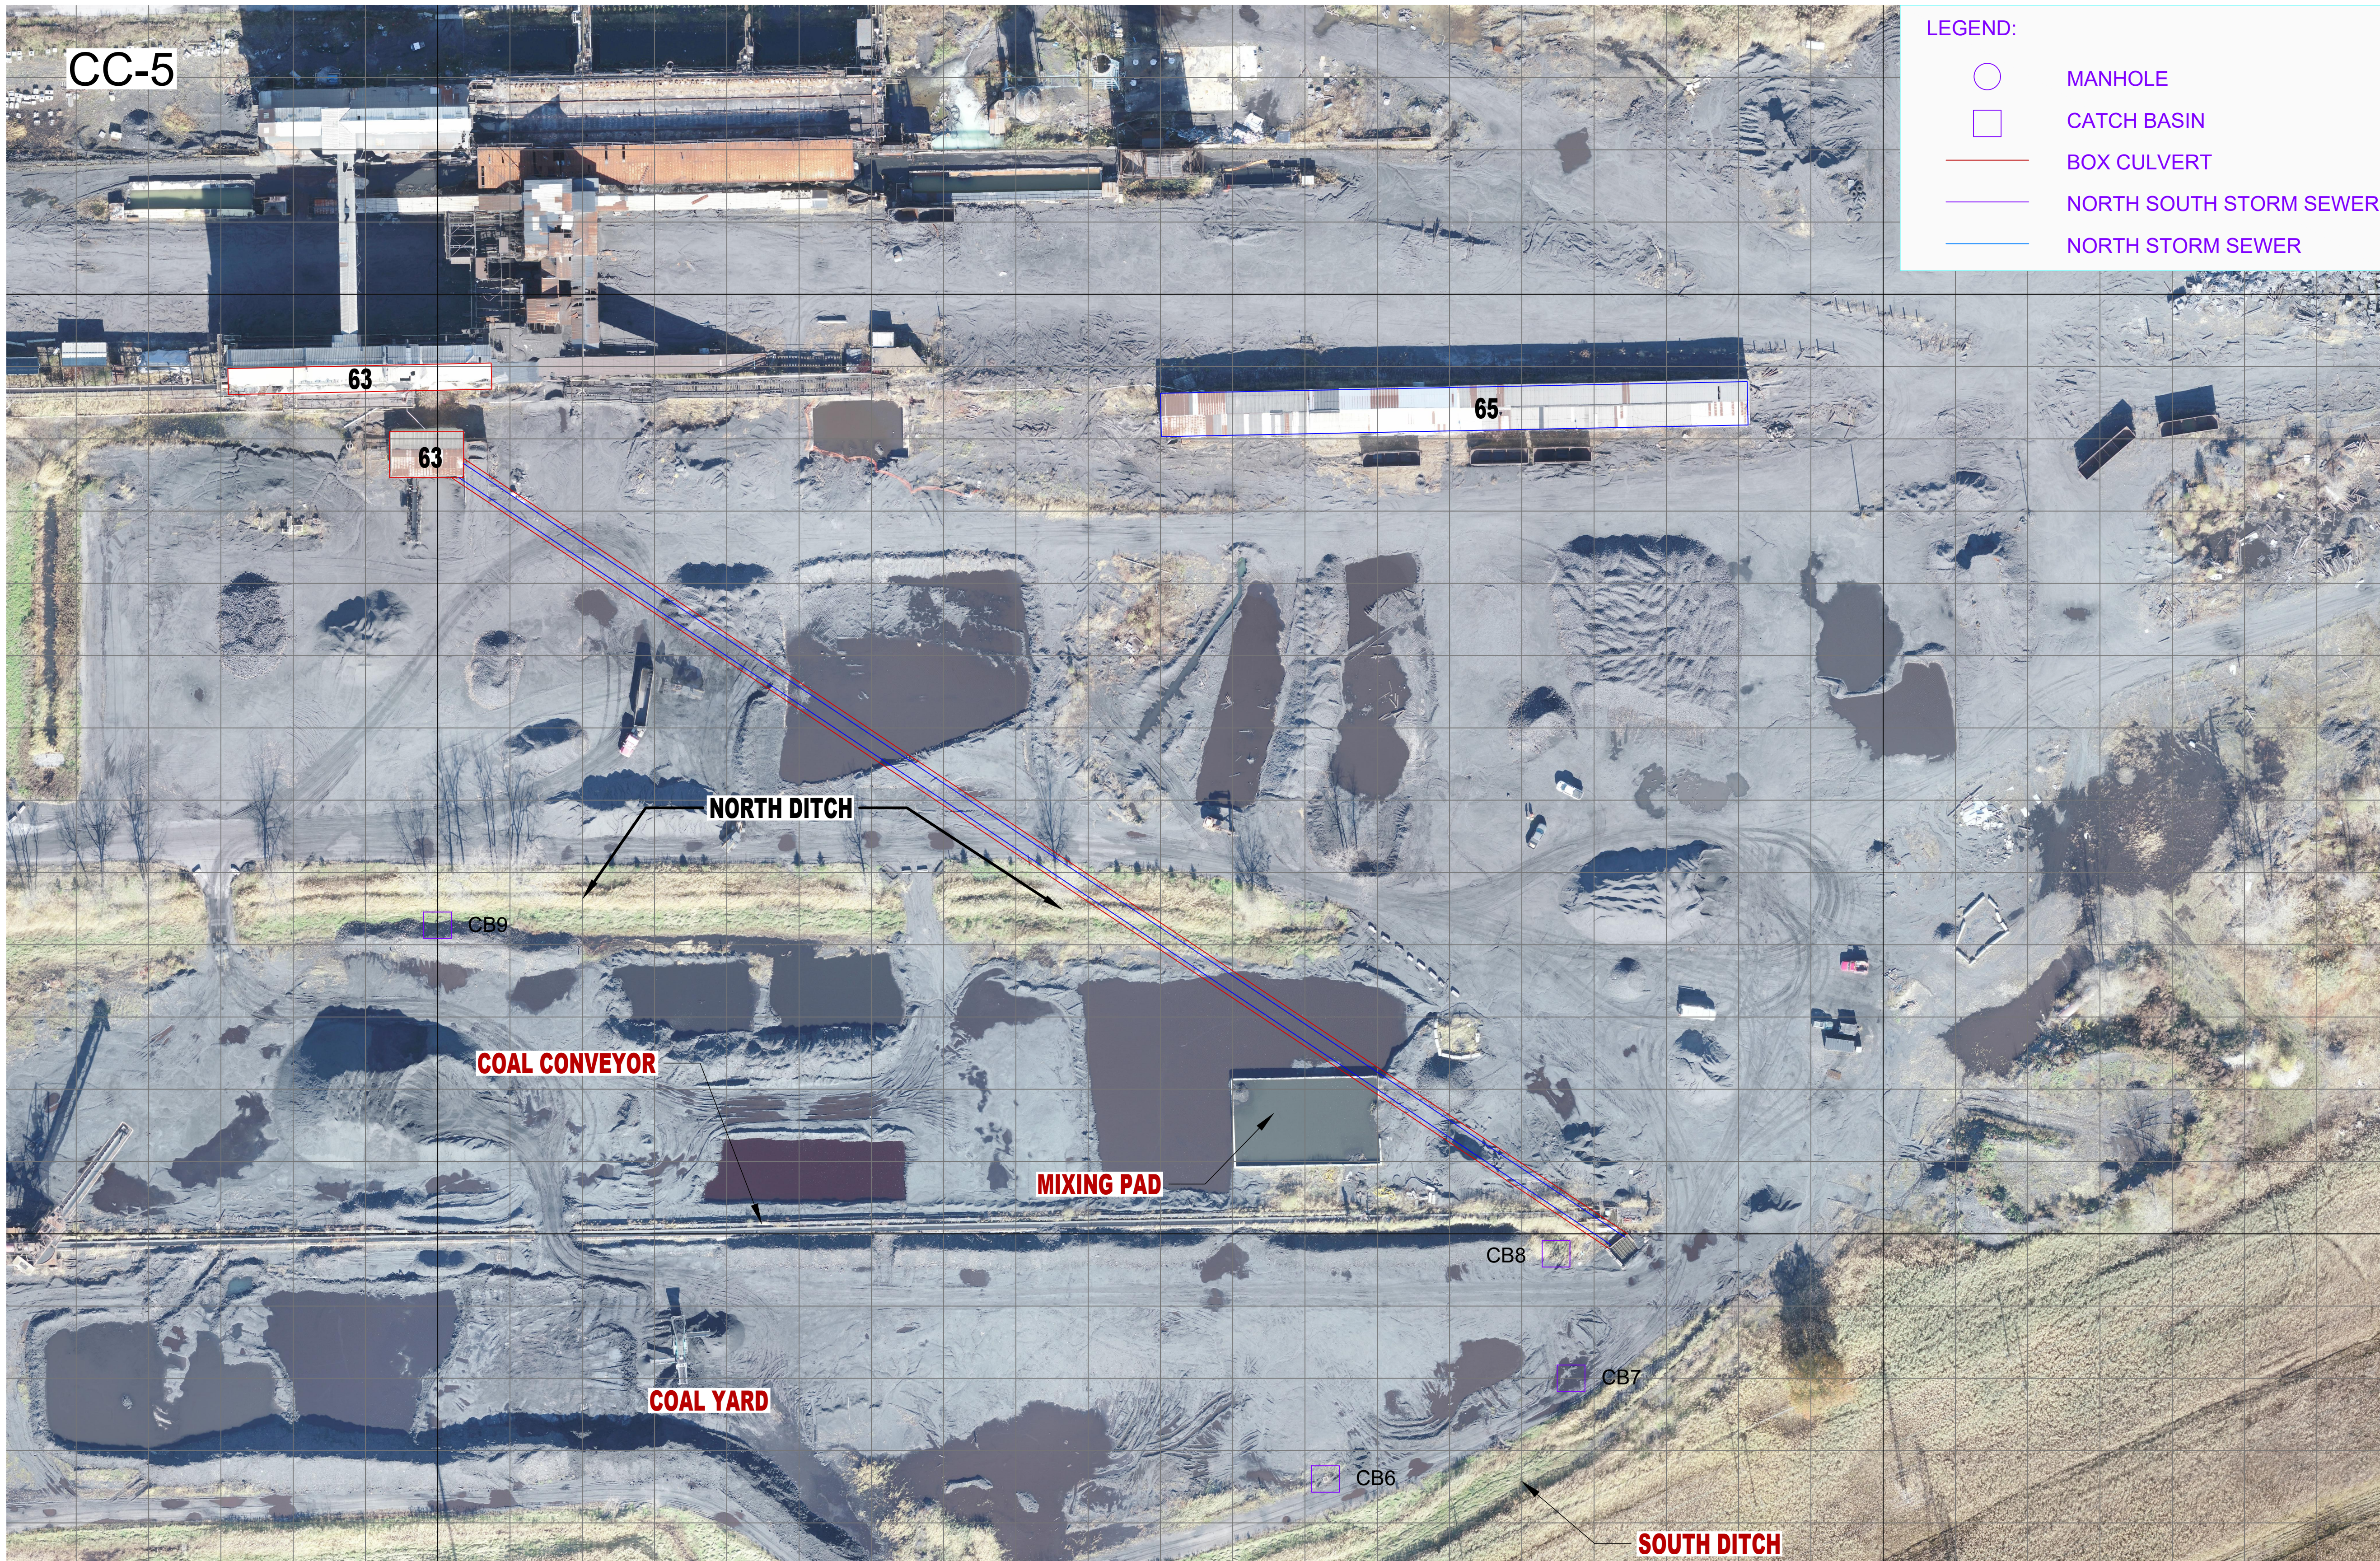
**FIGURE 5**

NOTE: SEWER LOCATIONS ARE APPROXIMATE.

- MANHOLE
- CATCH BASIN
- BOX CULVERT
- NORTH SOUTH STORM SEWER
- NORTH STORM SEWER

- Sedimentation Pool #003 – Figure 5, Grids N15 to N20;
  - North Ditch- Figures 5 and 6;
  - Sedimentation Pool #002 – Figure 5, Grids I22 to M22;
  - Storm Water Retention Basin – Figure 7, Grids F26 to I27;

- Sedimentation Pool #003 – Figure 5, Grids N15 and N19; and
  - South Ditch, Figure 6 Grid AI28 and Figure 7, Grid N29.;
- Stone Check Dams to direct flow to catch basins (Figures 5 and 6);

Fueling and maintenance of Facility equipment and vehicles will be performed in the designated area near the warehouse (Figure 3, Building 18) and at the coal yard pump (Figure 5, Grid M27) that are regularly inspected for the presence of any leaks or spills and will be closely monitored in conjunction with the terms of this SWPPP.

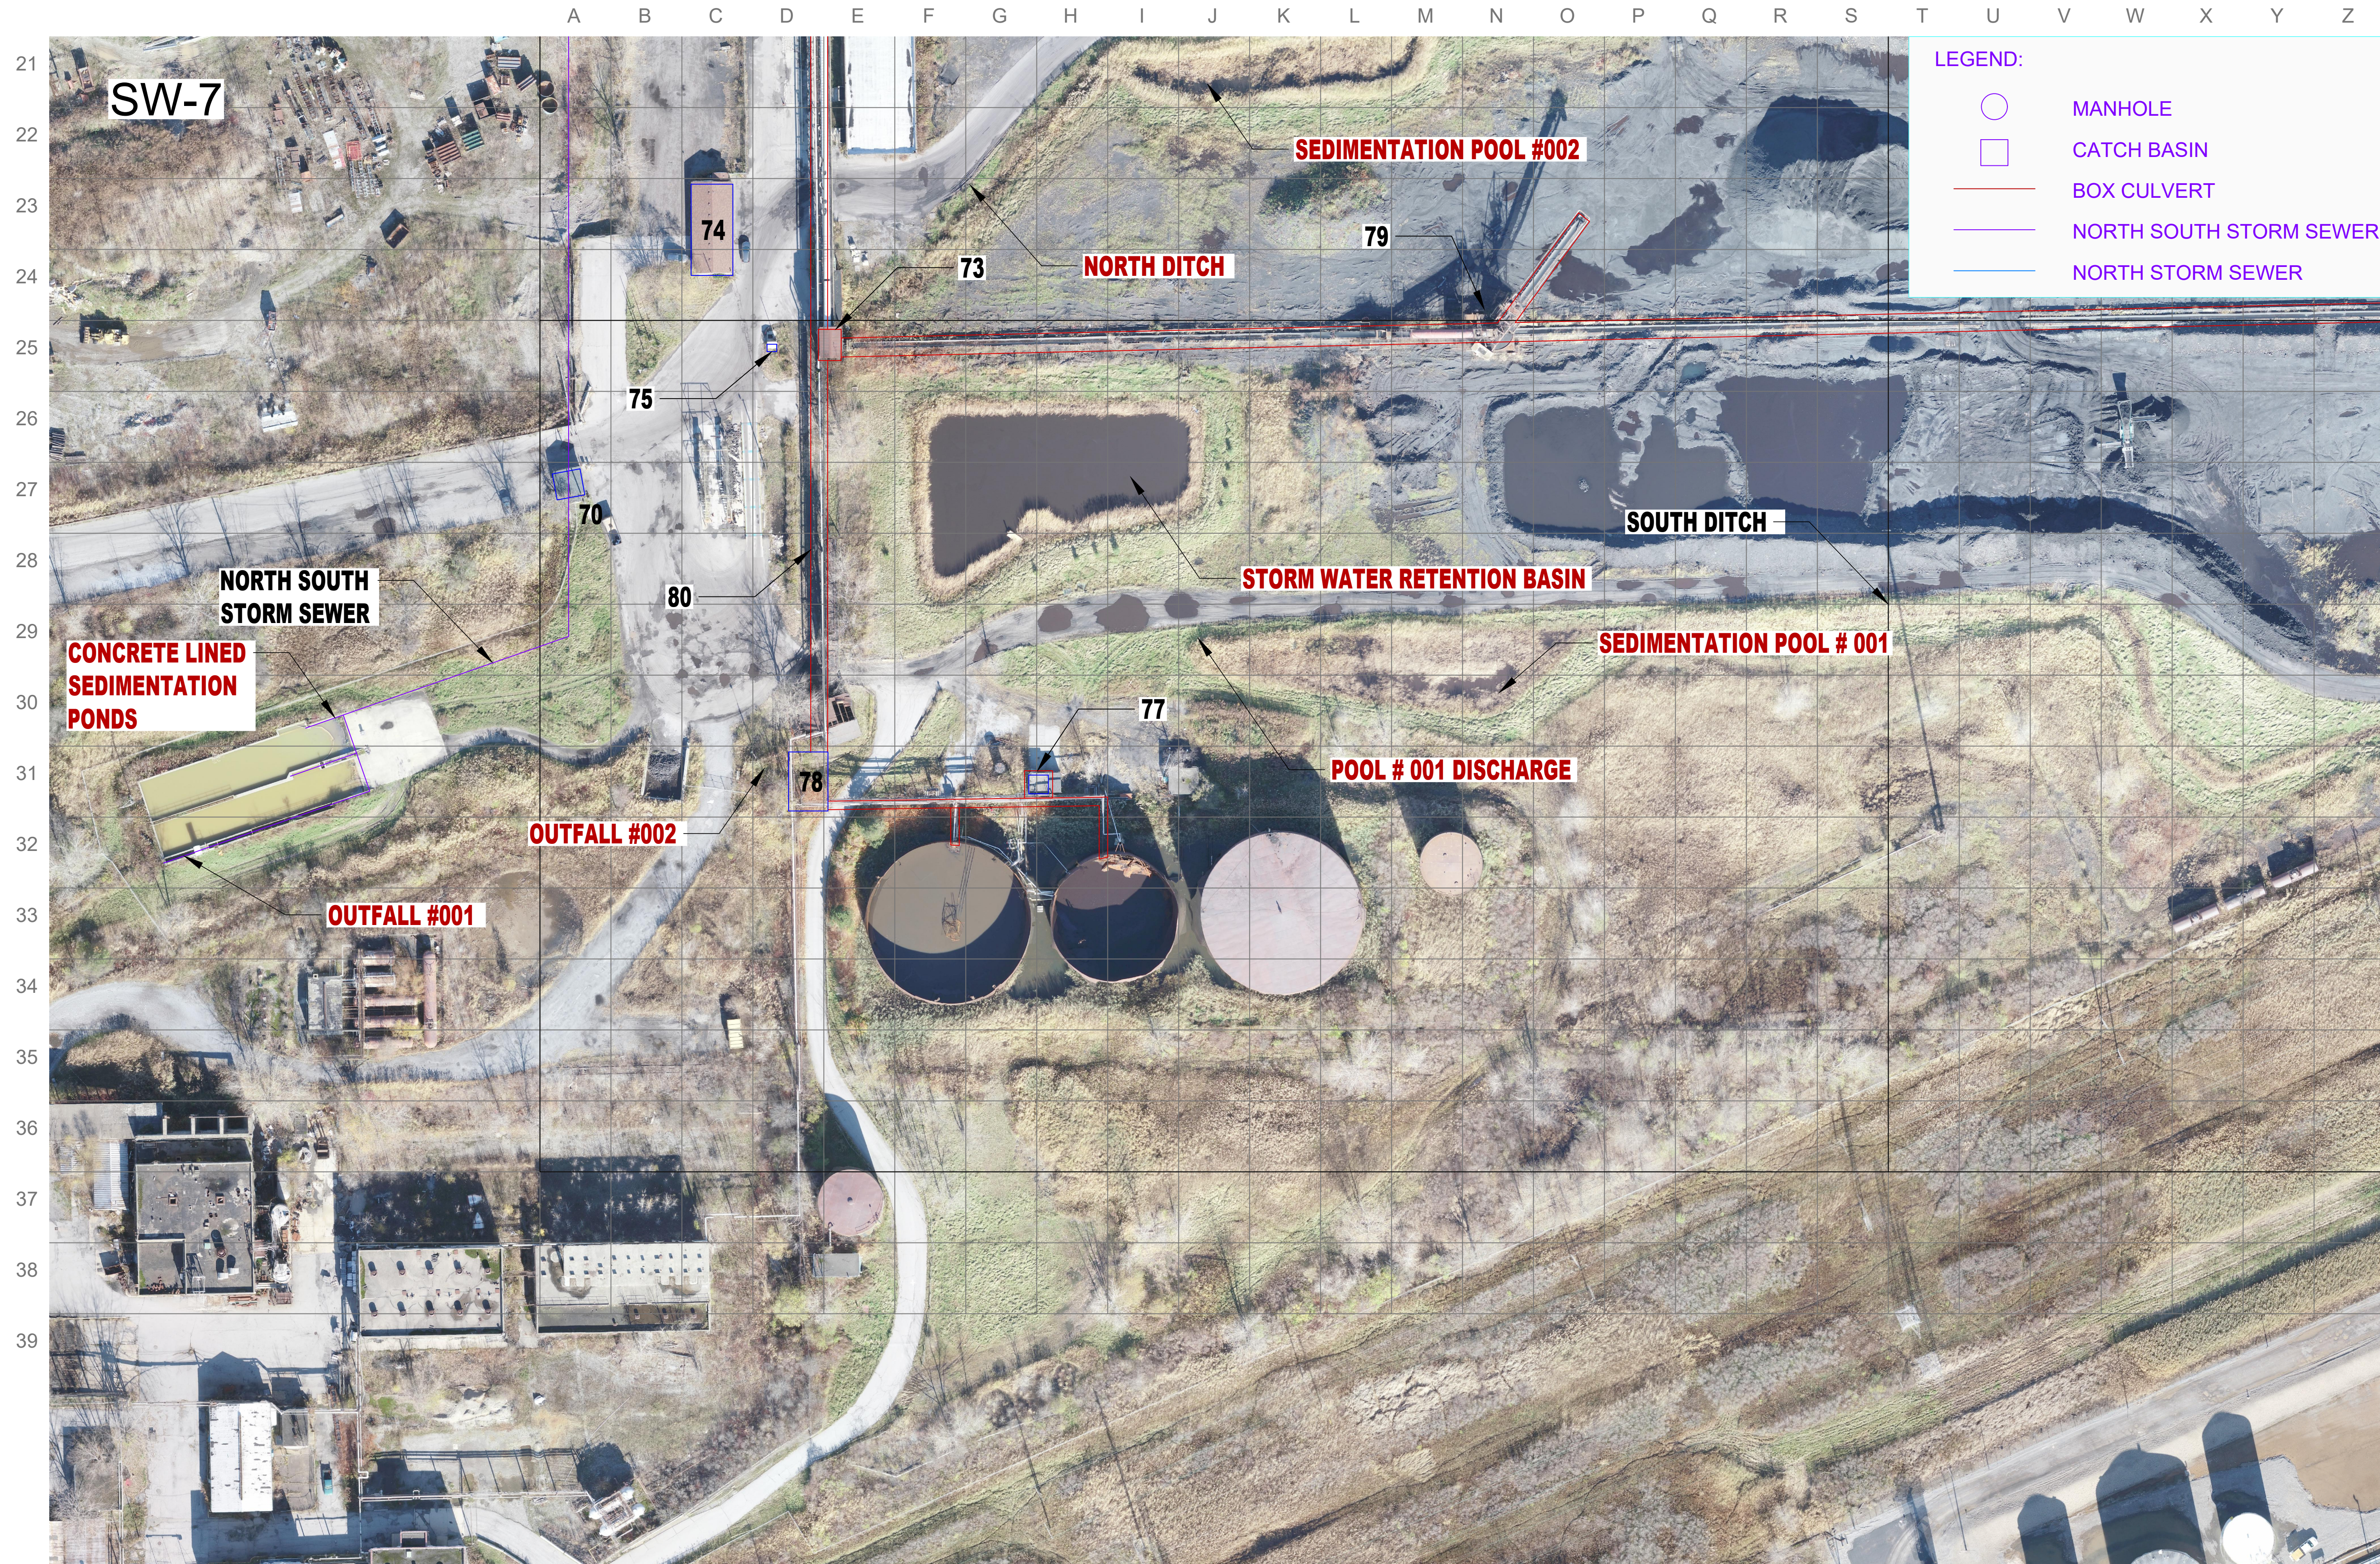
**FIGURE 7**  
DRAWING NUMBER  
**107A**

- MANHOLE
- CATCH BASIN
- BOX CULVERT
- NORTH SOUTH STORM SEWER
- NORTH STORM SEWER

- Sedimentation Pool #001 – Figure 7, Grids J29 to O29;
  - South Ditch – Figures 6 and 7; and

Water collected in the diked area around the EQ and associated tanks (Tanks 20 to 24, Figure 7, Grids E32 to N43) will be tested prior to discharge. If the water meets the Industrial Waste Permit Criteria and no detection of ammonia or mercury above POTW discharge criteria, the water will be discharged to the Sewer (POTW). If the water does not meet the discharge criteria, it will be pumped to a weir tank for treatment. DEC will be notified if treatment is required.

Stormwater in the former process area (AOI 2) that falls outside of the secondary containments is routed to the two concrete lined settling/skimming ponds (Figure 7) through the plant storm sewer system. The runoff is collected in the sump behind Building 001 (known as the Collection or Mansion Sump) in the northwest corner of the property (Figure 3). Initial sediment removal occurs in the collection sump. Any sheen on the water is removed in the collection sump. The runoff overflows to the secondary sewer system (North South Sewer) that conveys flow to the south. The runoff is discharged to the concrete lined settling ponds (Figure 7) from the North South Storm Sewer through an underground manifold. The runoff is held in the ponds to allow settling and skimming (oil separation) and is subsequently discharged through Outfall 001. The concrete lined settling pond system has been designed to remove coal fines, along with incidental amounts of oil and other materials that may enter the catch basins in the former process areas.

During any offsite shipment of coal, coke or other bulk materials, a staging/tire wash station will be established in the vicinity of the scale (Figure 7, Grids C26 and C27). Tires of over the road haulage trucks leaving the site will be inspected to ensure there is no mud or industrial materials on the tires. Any excess accumulations of mud or industrial materials will be removed onsite before reaching the truck scale area. The removed materials will be accumulated in a drum or roll off container prior to characterization.

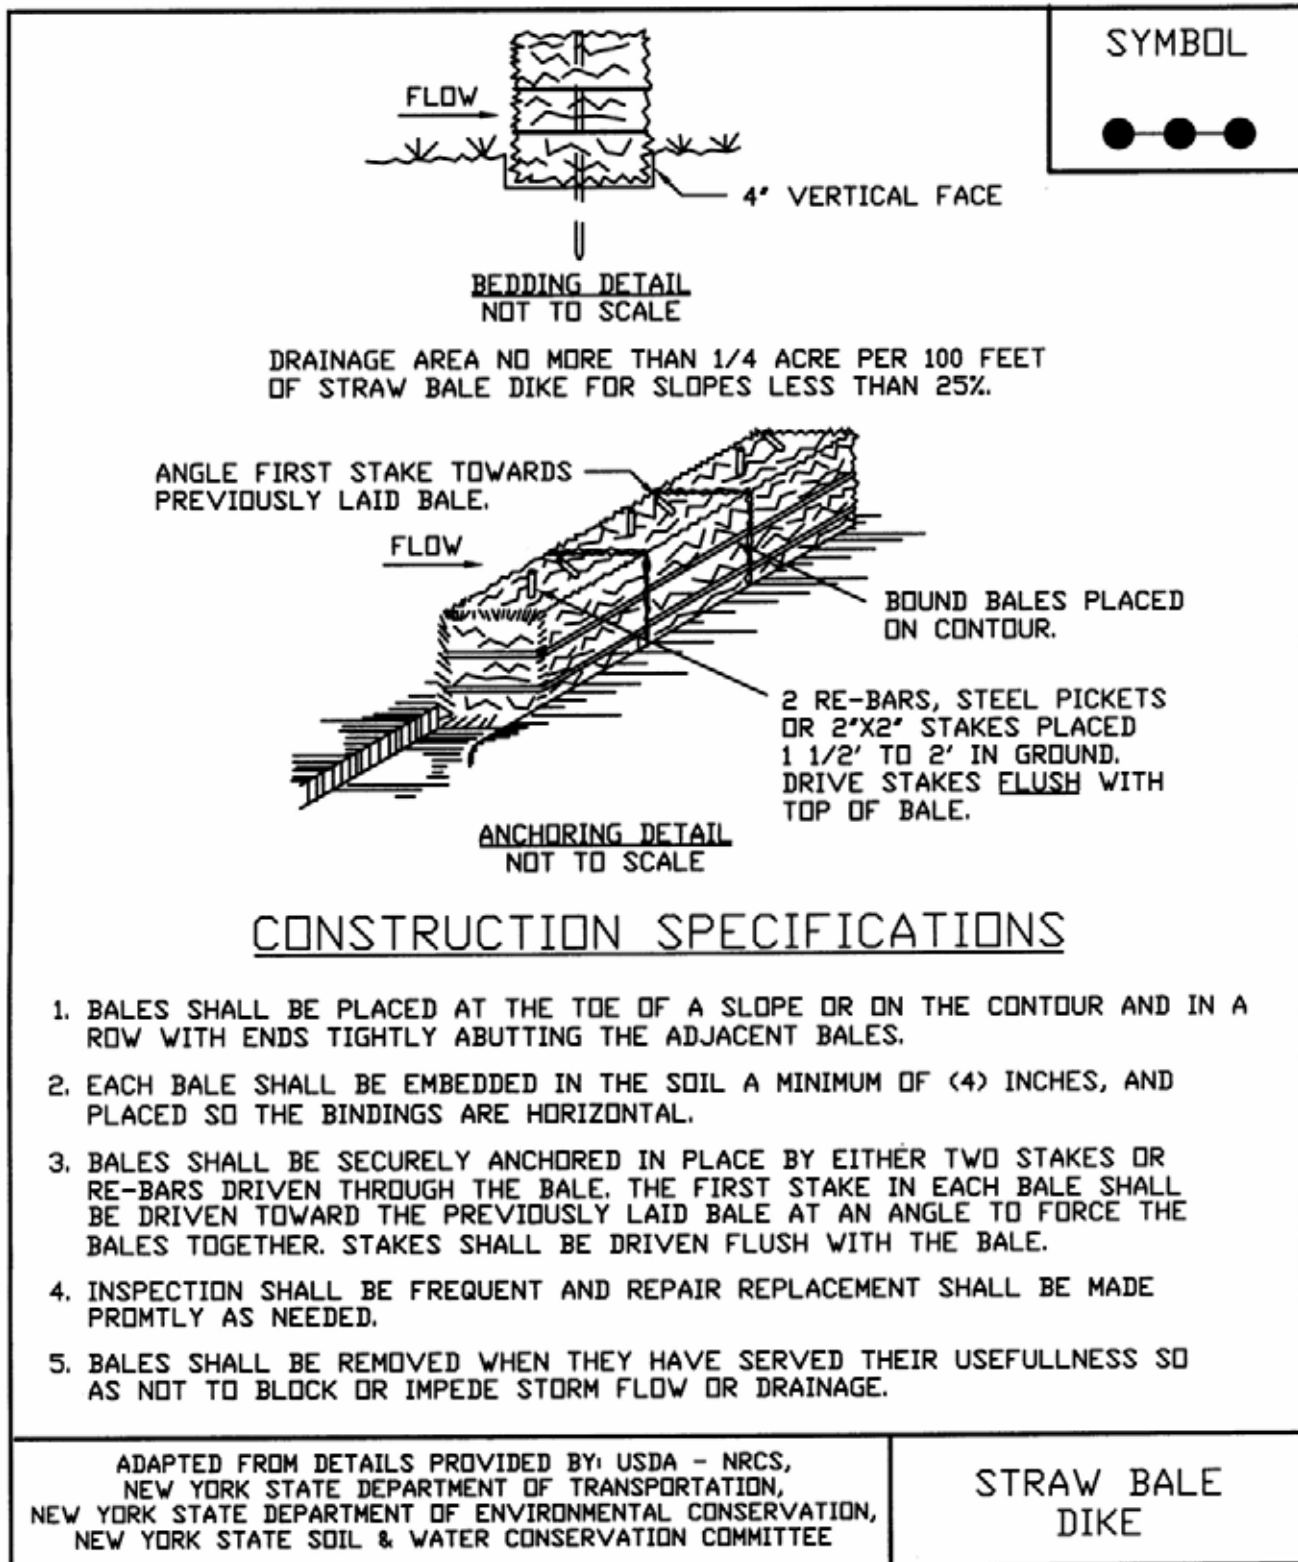
**Figure 5A.7  
Straw Bale Dike**

A temporary barrier of straw, or similar material, used to intercept sediment laden runoff from small drainage areas of disturbed soil.

The above table is adequate, in general, for a one-inch rainfall event. Larger storms could cause failure of this practice. Use of this practice in sensitive areas for longer than one month should be specifically designed to store expected runoff. All bales shall be placed on the contour with cut edge of bale adhering to the ground. See Figure 5A.7 on page 5A.18 or details.

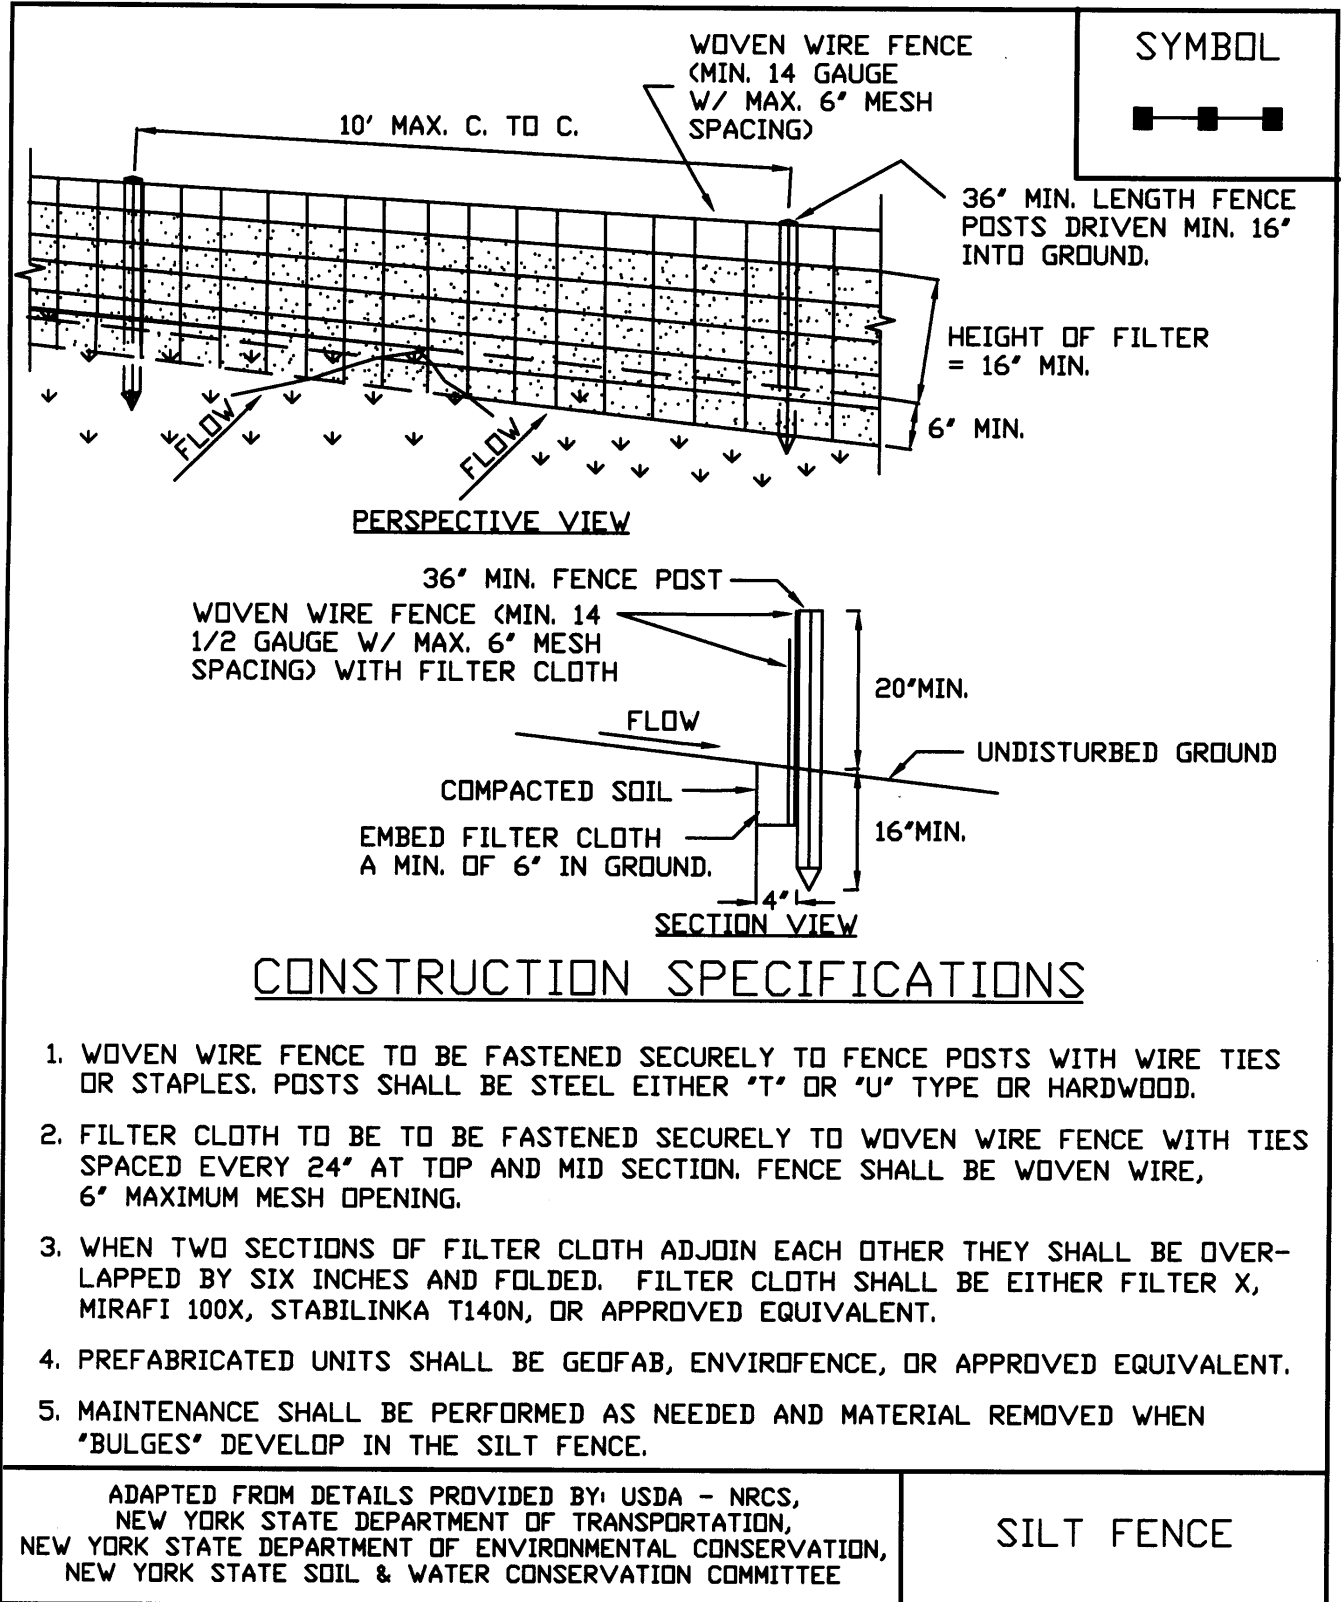
**Figure 5A.8**  
**Silt Fence**

A temporary barrier of geotextile fabric installed on the contours across a slope used to intercept sediment laden runoff from small drainage areas of disturbed soil.

4. Prefabricated Units: Envirofence, Geofab, or approved equal, may be used in lieu of the above method providing the unit is installed per details shown in Figure 5A.8.

- Stormwater controls are inspected daily and maintained as soon as any potential issue is observed, including but not limited to, repairing silt fence, placing stone check dams to prevent flow from circumventing stormwater inlets, and replacing silt socks as needed.

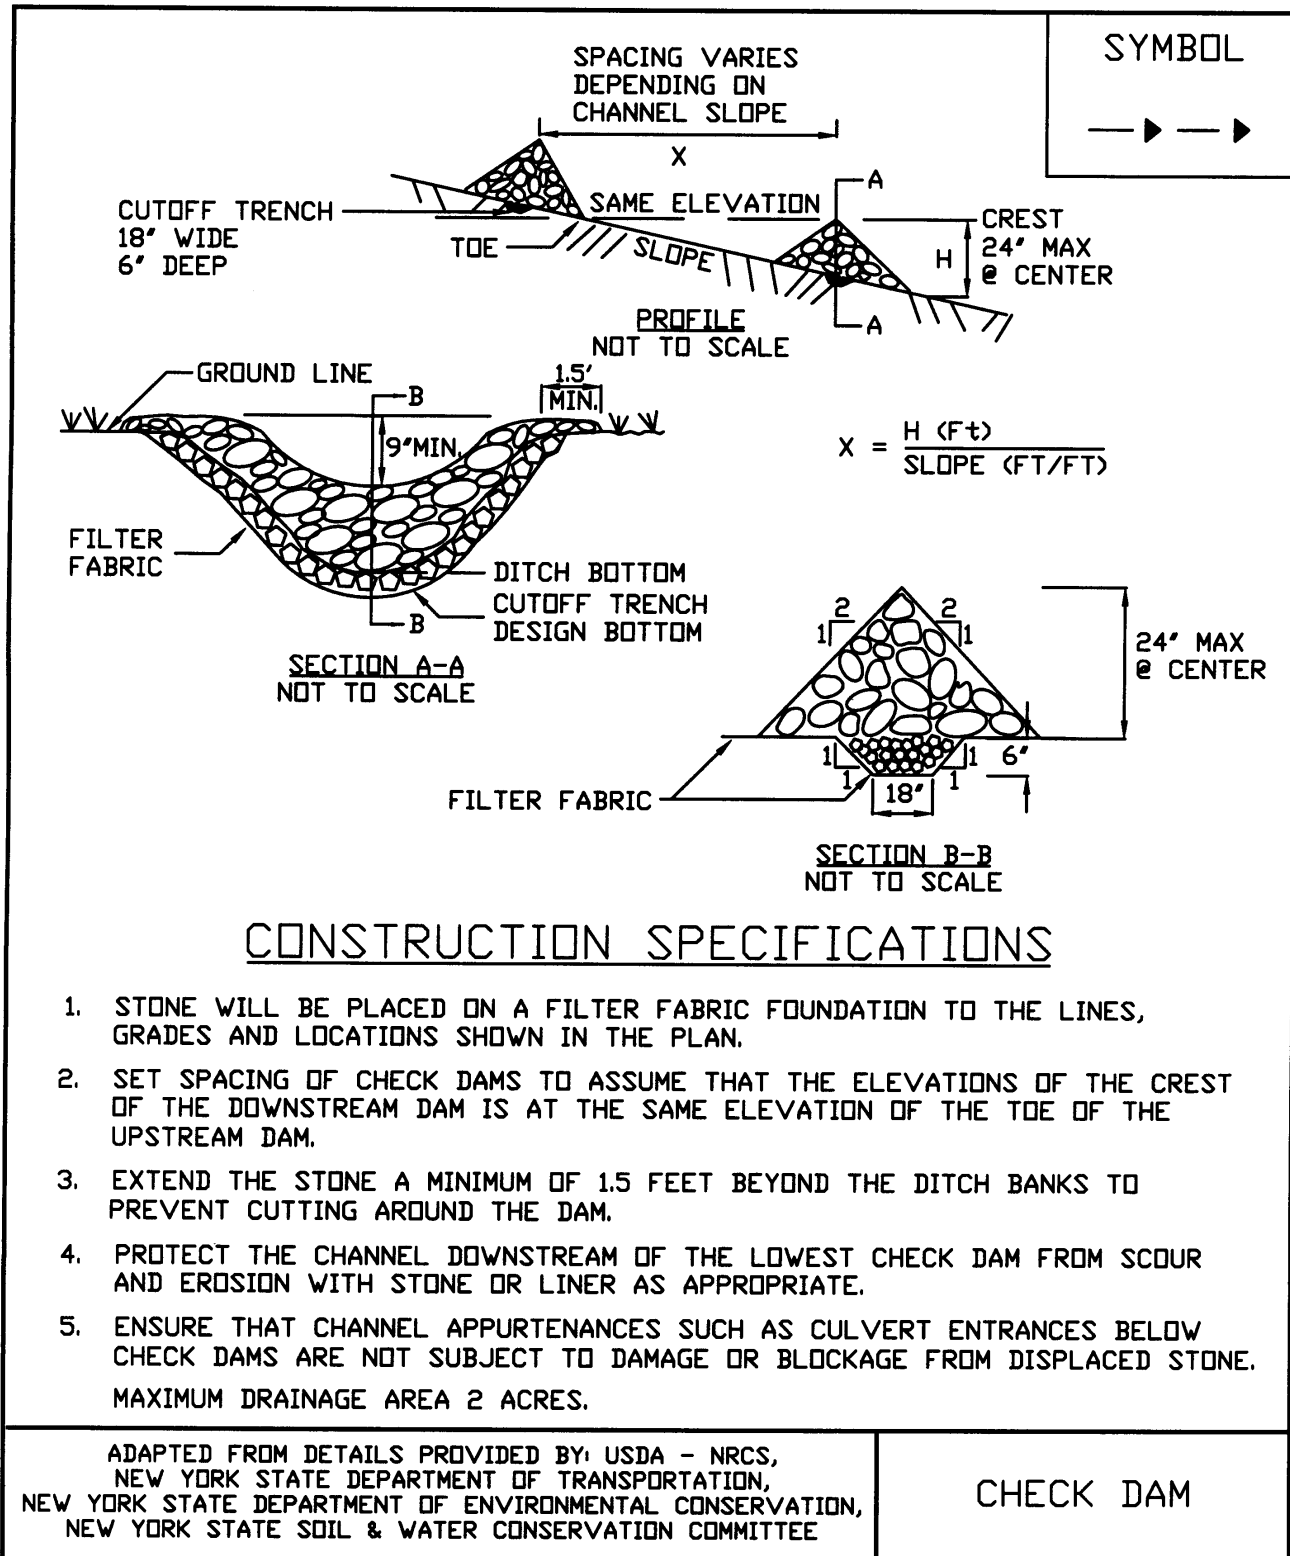
**Figure 5A.9  
Check Dam**

Small barriers or dams constructed of stone, bagged sand or gravel, or other durable material across a drainage way.

Remove sediment accumulated behind the dam as needed to allow channel to drain through the stone check dam and prevent large flows from carrying sediment over the dam. Replace stones as needed to maintain the design cross section of the structures.
