## **Stormwater Pollution Prevention Plan**

Riverview Innovation & Technology Campus  
3875 River Road  
Tonawanda, New York 14150  
BCP Site No. C915353

05/29/2020

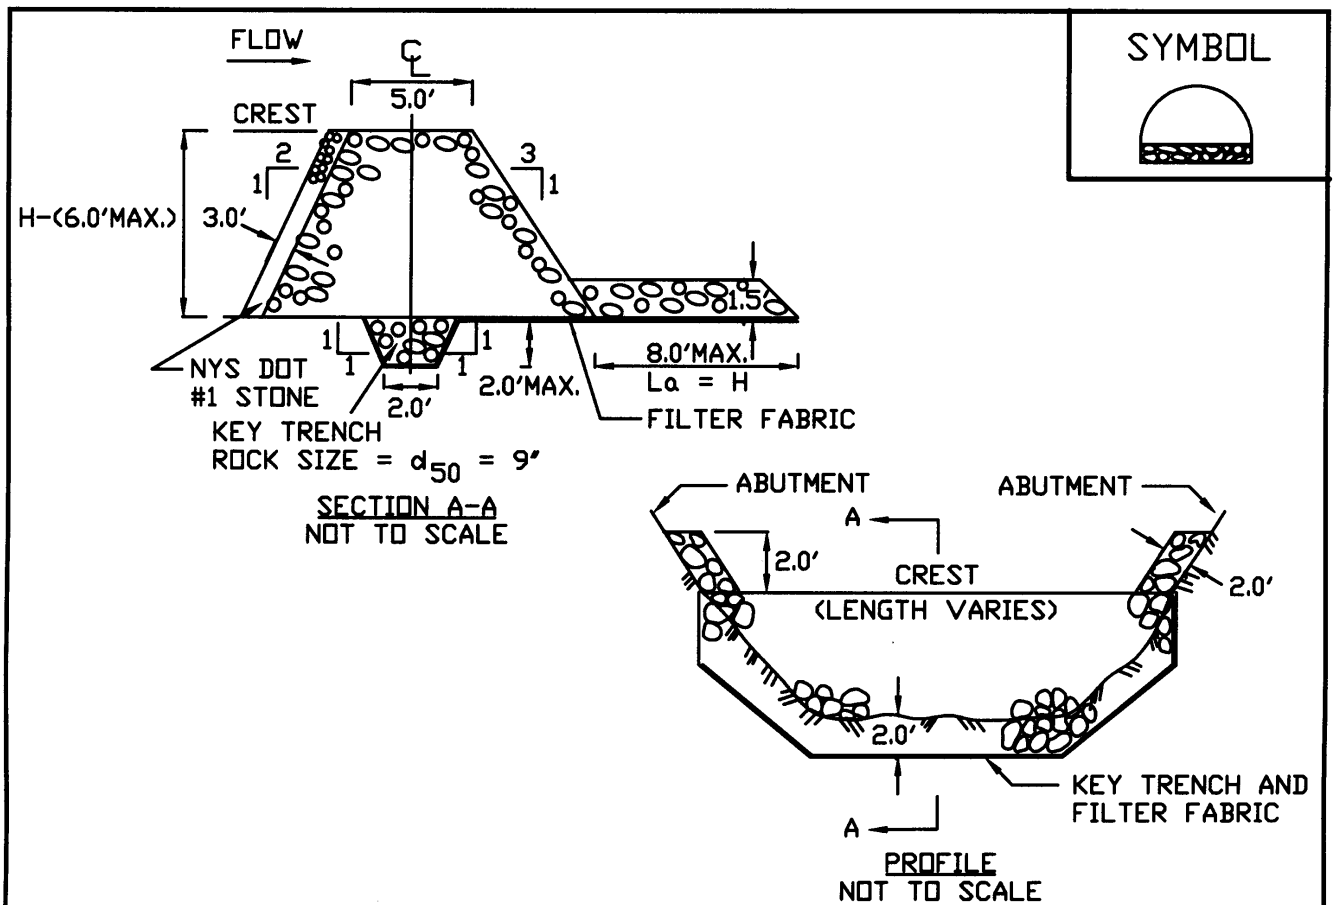
**Figure 5A.10  
Rock Dam**

A rock embankment located to capture sediment.

Remove the structure and any sediment immediately after the construction area has been permanently stabilized. All water should be removed from the basin prior to the removal of the rock dam. Sediment should be placed in designated disposal areas and not allowed to flow into streams or drainage ways during structure removal.

1. THE AREA UNDER THE ROCK DAM SHALL BE CLEARED AND STRIPPED OF ROOTS AND OTHER OBJECTIONABLE MATERIAL. THE RESERVOIR SHALL BE CLEARED AS NEEDED TO FACILITATE SEDIMENT REMOVAL.
2. DIMENSIONS SHOWN ARE MINIMUM. TRENCH SHALL BE EXCAVATED FROM ABUTMENT TO ABUTMENT ON THE DAM CENTERLINE. FILTER FABRIC SHALL BE PLACED FROM UPSTREAM EDGE OF KEYTRENCH TO DOWNSTREAM EDGE OF APRON. JOINTS WILL LAP A MINIMUM OF 1 FT. WITH UPSTREAM STRIP ON TOP.
3. CONSTRUCT THE ROCK EMBANKMENT TO THE DIMENSIONS SHOWN ON THE DRAWING. ROCK ABUTMENTS SHALL BE MAINTAINED 2 FT. ABOVE THE CREST.
4. THE ROCK DAM SHALL BE CONSTRUCTED PRIOR TO CLEARING THE BASIN AREA. STABILIZE ALL DISTURBED AREAS, EXCEPT THE BASIN AREA, WITH TEMPORARY SEEDING.
5. FENCES AND WARNING SIGNS SHOULD BE PLACED AS APPROPRIATE.

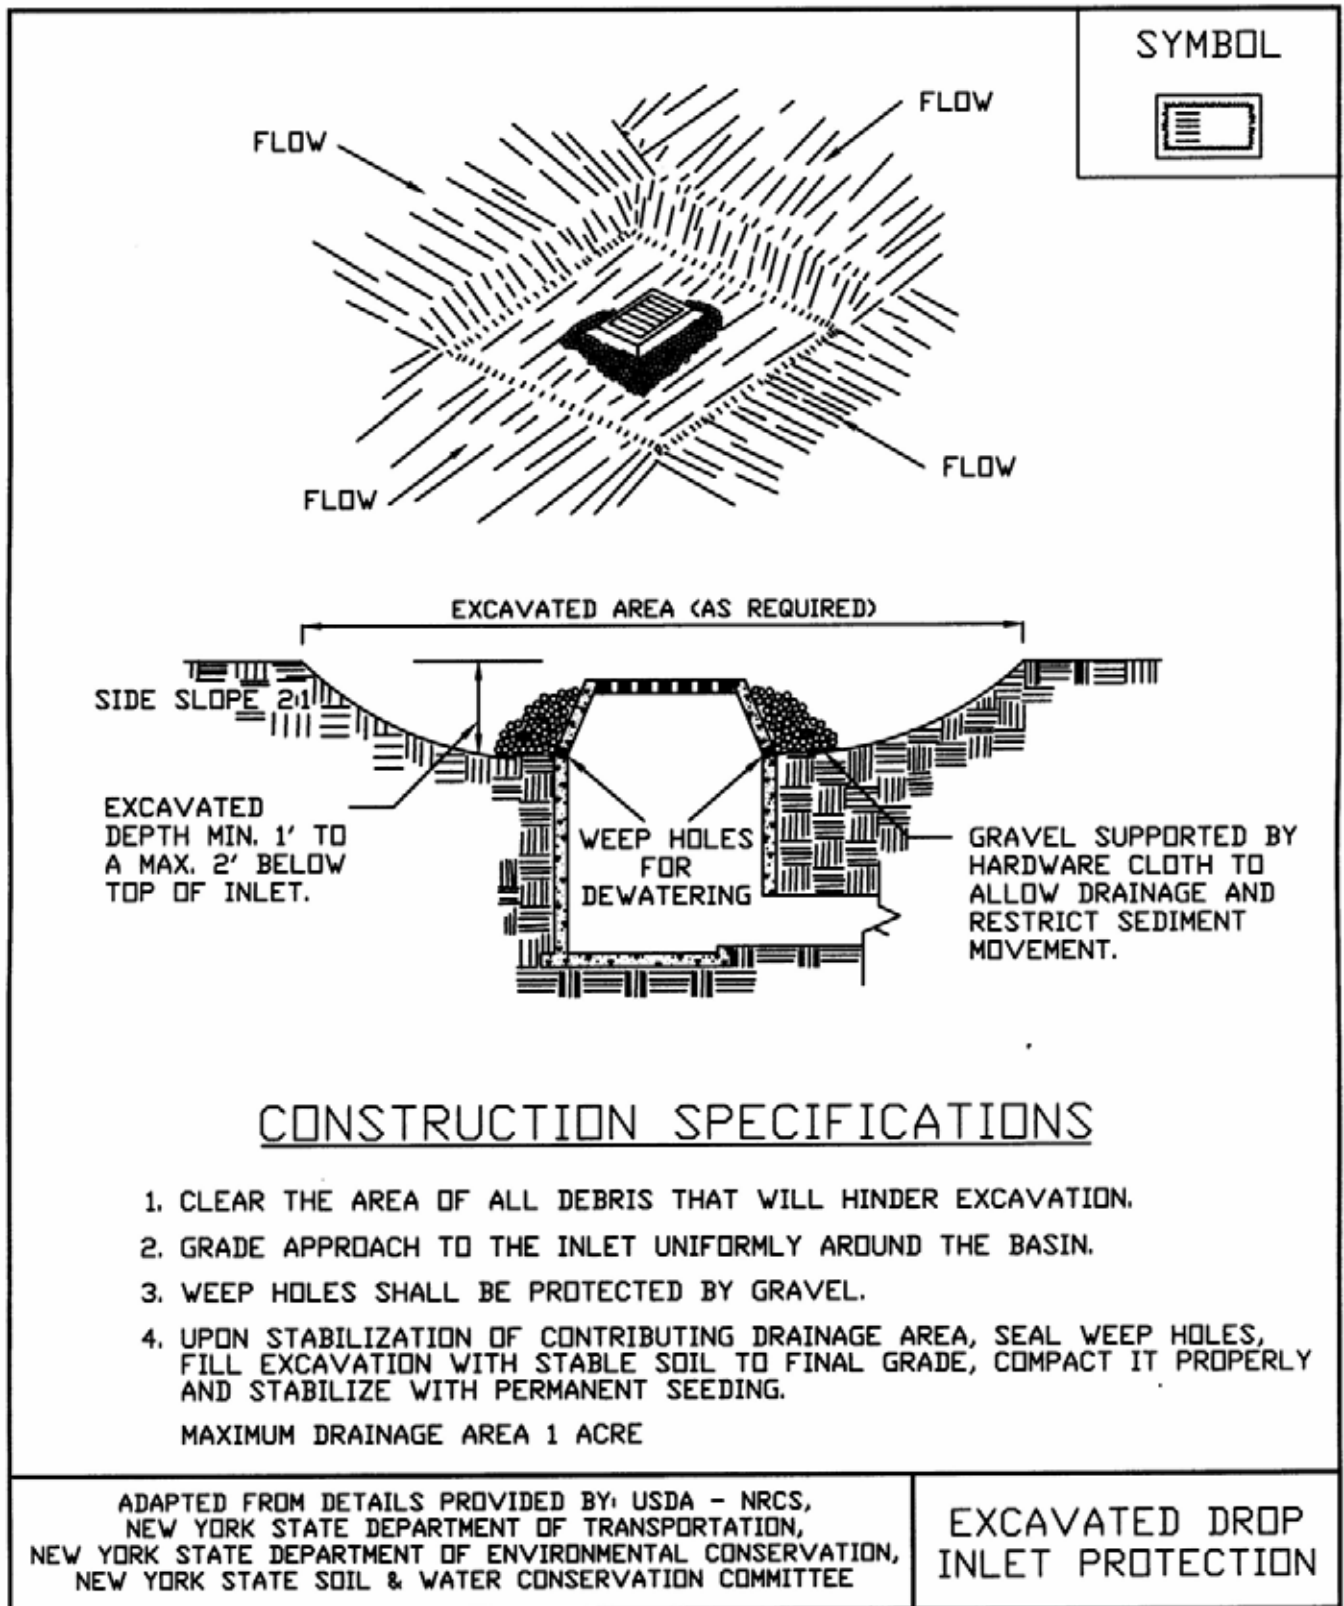
**Figure 5A.11  
Excavated Drop Inlet Protection**

A temporary, somewhat permeable barrier, installed around inlets in the form of a fence, berm or excavation around an opening, trapping water and thereby reducing the sediment content of sediment laden water by settling.

The structure should be inspected after every storm event. Any sediment should be removed and disposed of on the site. Any stone missing should be replaced. Check materials for proper anchorage and secure as necessary.
