Superfund and Brownfield Progress Update

June 29, 2022

Riverview Innovation &
Technology Campus,
#C915353

ST24 Secondary Containment

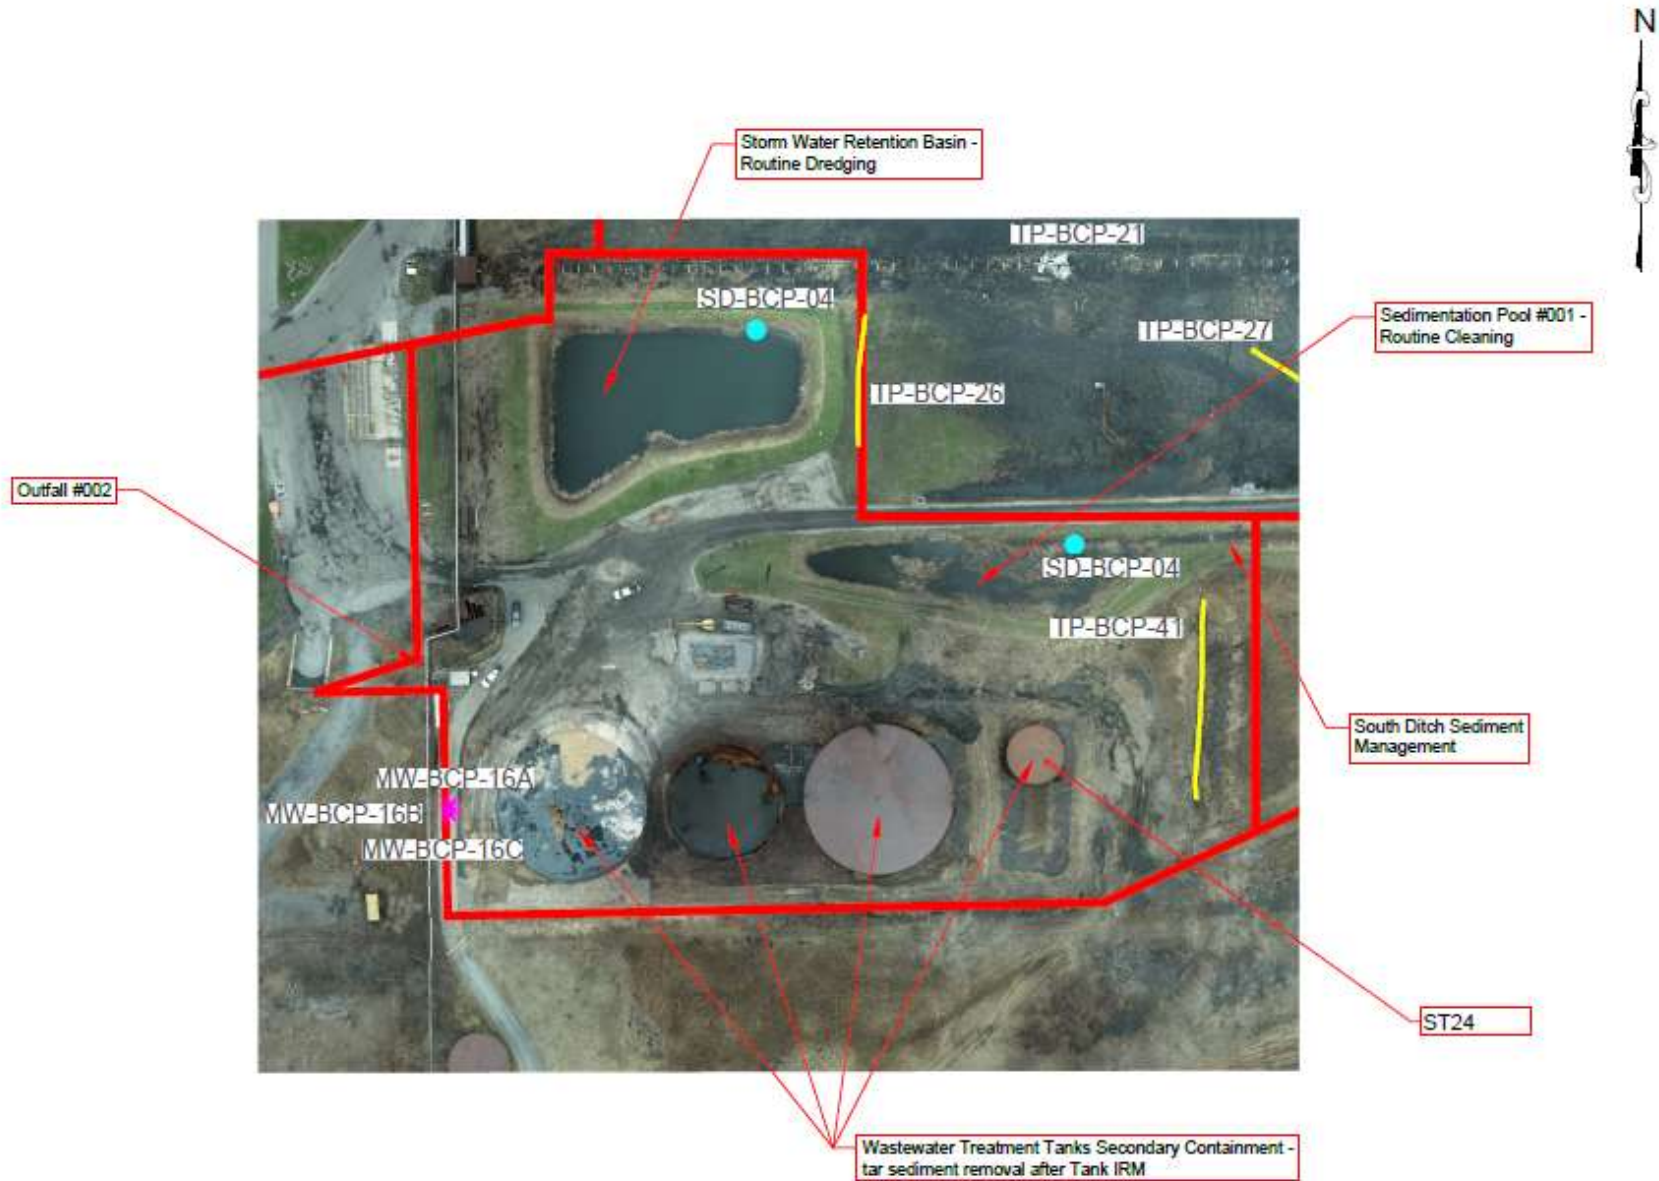
FIGURE 4 - 62

- Staining observed in sand subbase below tank ST24.
- Soil sampling completed under a supplemental investigation work plan.
- Samples collected June 16, 2022.
- Results will be used to determine what further actions are needed as part of the site remedy.

<p>INVENTUM ENGINEERING 41 CARLISLE DRIVE SUITE C HERRIDON, VIRGINIA 20170 (703) 722-6049 www.InventumEng.com</p>	<p>NATURE AND EXTENT WATER TREATMENT AREA - AOI 6 RIVERVIEW INNOVATION & TECHNOLOGY CAMPUS, INC. 3875 RIVER ROAD TONAWANDA, NEW YORK 14150 BCP SITE No. C915363</p>	<p>DATE: 08/20/2018 DRAWN BY: [REDACTED] CHECKED BY: [REDACTED] APPROVED BY: [REDACTED]</p> <p>THIS DOCUMENT IS THE PROPERTY OF INVENTUM ENGINEERING. IT IS TO BE USED ONLY FOR THE PROJECT AND SITE SPECIFICALLY IDENTIFIED IN THE TITLE. IT IS NOT TO BE REPRODUCED, COPIED, OR TRANSMITTED IN ANY FORM OR BY ANY MEANS, ELECTRONIC OR MECHANICAL, INCLUDING PHOTOCOPYING, RECORDING, OR BY ANY INFORMATION STORAGE AND RETRIEVAL SYSTEM, WITHOUT THE WRITTEN PERMISSION OF INVENTUM ENGINEERING.</p> <p>NOTICE: THIS DOCUMENT HAS BEEN PREPARED BY INVENTUM ENGINEERING, INC. AS AN INSTRUMENT OF SERVICE TO THE CLIENT. IT IS THE PROPERTY OF INVENTUM ENGINEERING, INC. AND IS NOT TO BE REPRODUCED, COPIED, OR TRANSMITTED IN ANY FORM OR BY ANY MEANS, ELECTRONIC OR MECHANICAL, INCLUDING PHOTOCOPYING, RECORDING, OR BY ANY INFORMATION STORAGE AND RETRIEVAL SYSTEM, WITHOUT THE WRITTEN PERMISSION OF INVENTUM ENGINEERING, INC.</p>

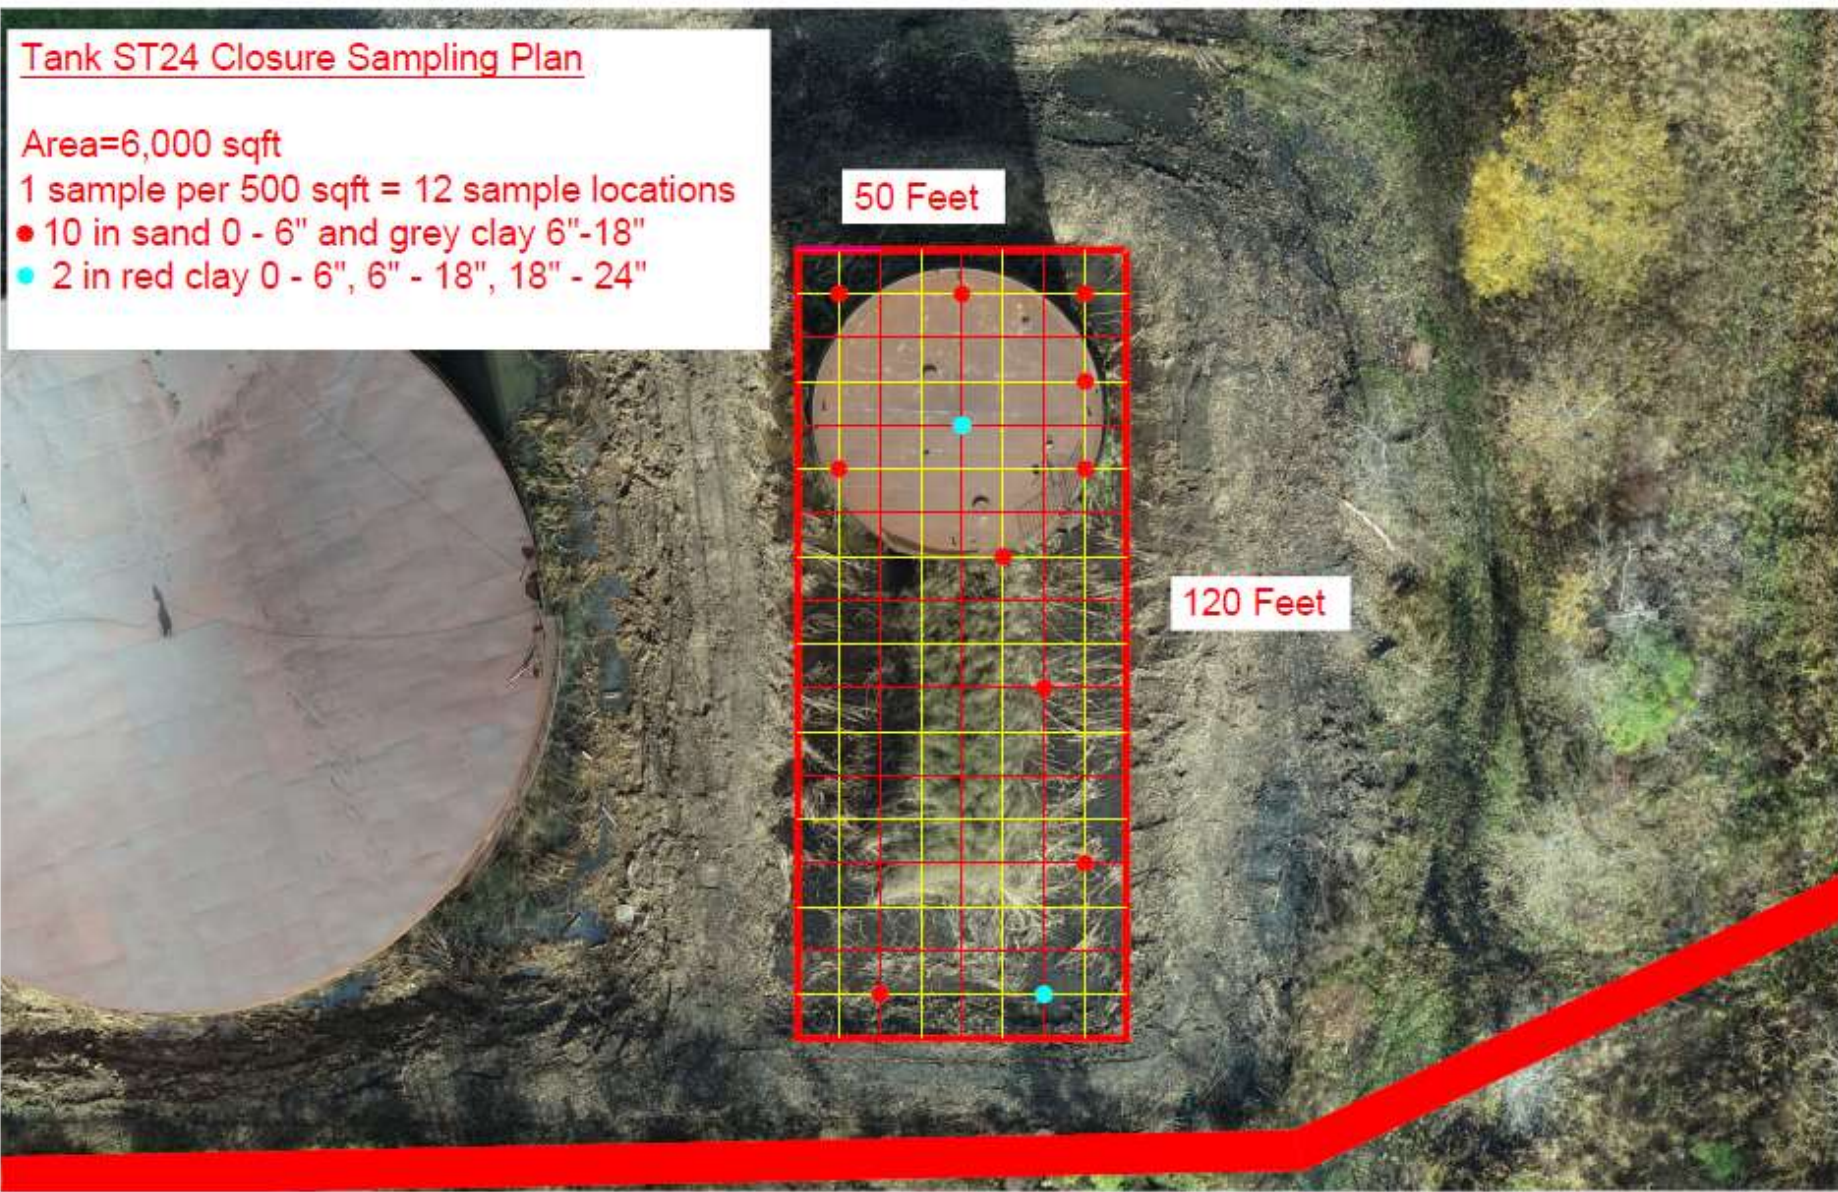
FIGURE 1

Tank ST24 Closure Sampling Plan

Area=6,000 sqft
 1 sample per 500 sqft = 12 sample locations

- 10 in sand 0 - 6" and grey clay 6"-18"
- 2 in red clay 0 - 6", 6" - 18", 18" - 24"

TANK ST24 CLOSURE SAMPLING
 RIVERVIEW/INNOVATION & TECHNOLOGY
 CAMPUS, INC.
 3875 RIVER ROAD
 TONAWANDA, NEW YORK 14150
 BCP SITE No. C915353
